How to Build a **BETTER-THAN-NEW** **SENECA II** & Overcome the ^{unexpected} Challenges of *an Aircraft Refurbishment*

Story and photos by Roger Battistoni

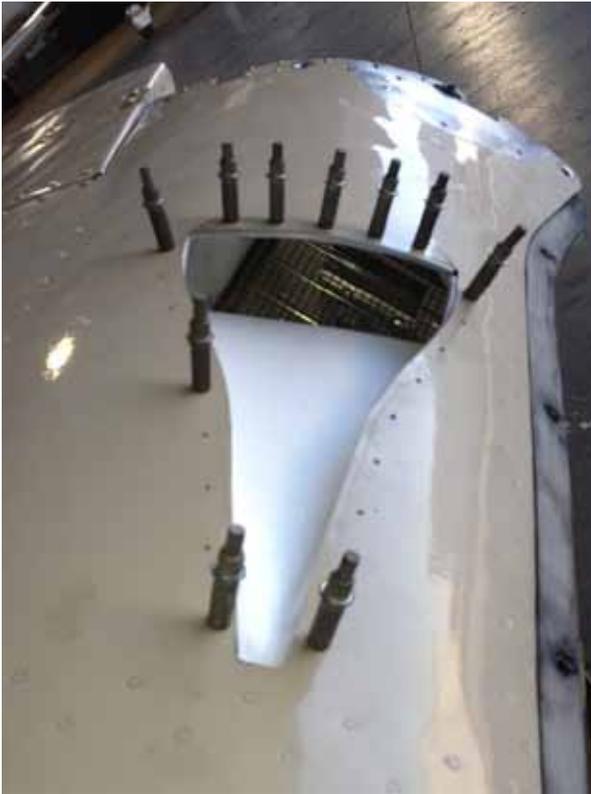
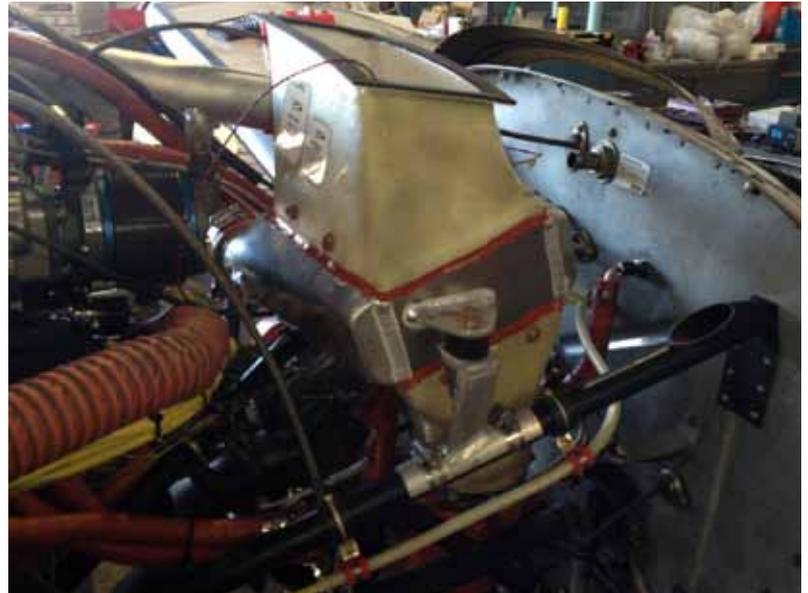
Because Seneca II turbocharged engines tend to run hot, a TurboPlus (www.turboplus.com) intercooler system was added to help bring down the temperatures. In addition to the intercooler upgrade, a wastegate from Merlyn Products, Inc. (www.merlynproducts.com) was added to decrease the sensitivity of the throttle changes on manifold pressure and reduces stress on the turbos. This will not only help to extend engine life, but will make things easier on the pilot as well!

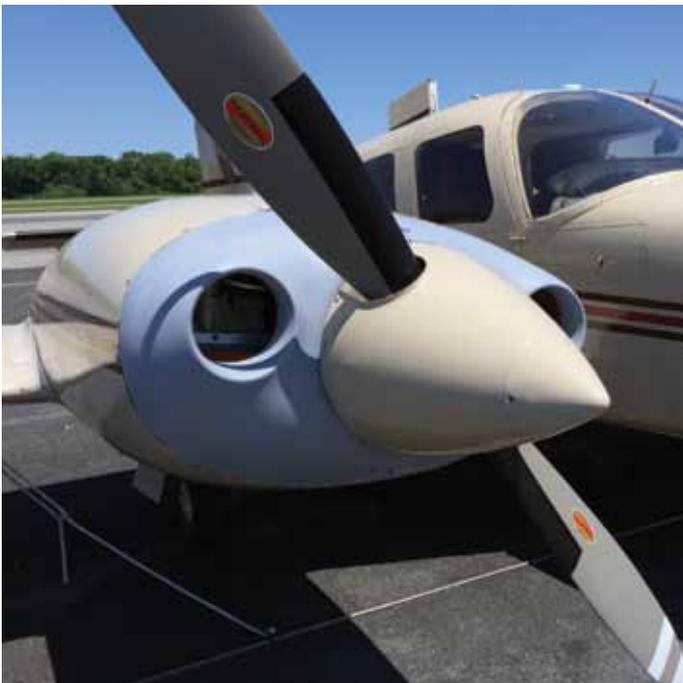
The owner opted for new Lopresti cowls.

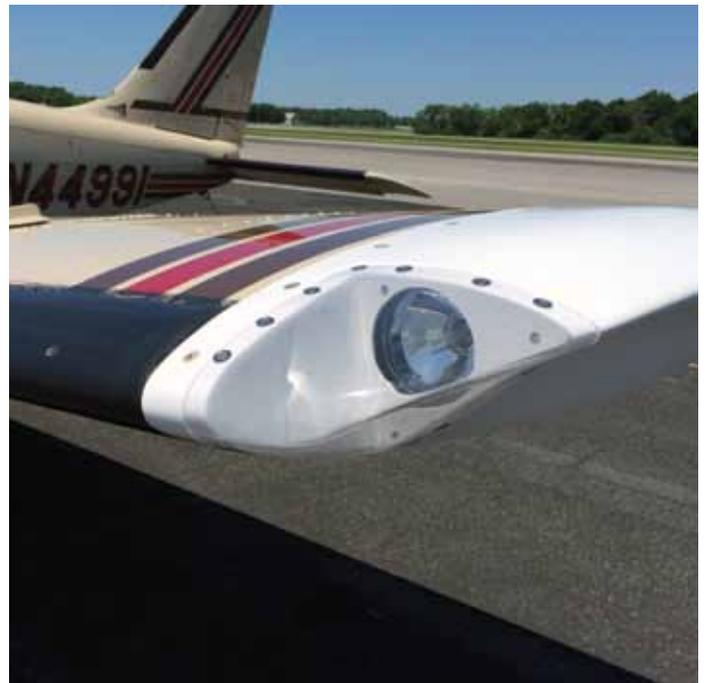
Since exterior lighting on the Seneca II's is lacking, HID wingtip lights from Knots-2-U (www.knots2u.com) were fitted.

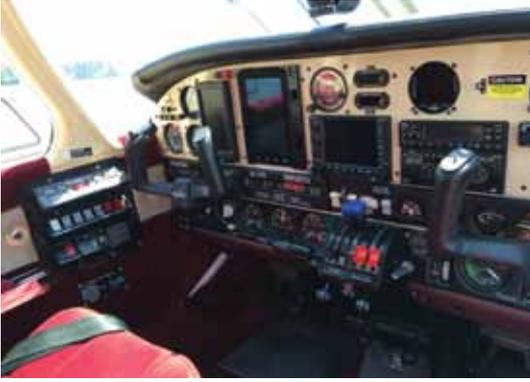
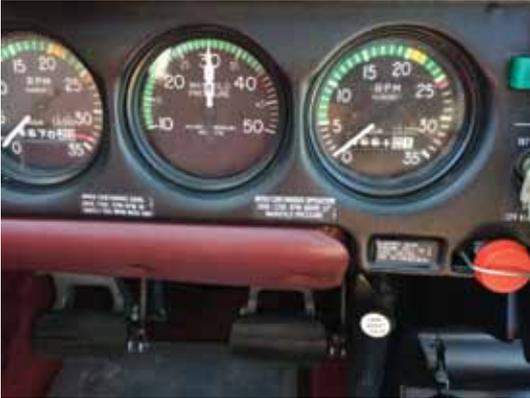
Before

The plane's panel was already fitted with the Garmin 530, so we added an Aspen PFD 1000 PRO, Garmin GTX 330 Transponder, Garmin 340 audio panel, JPI 760, and a Garmin 796 to round things out.

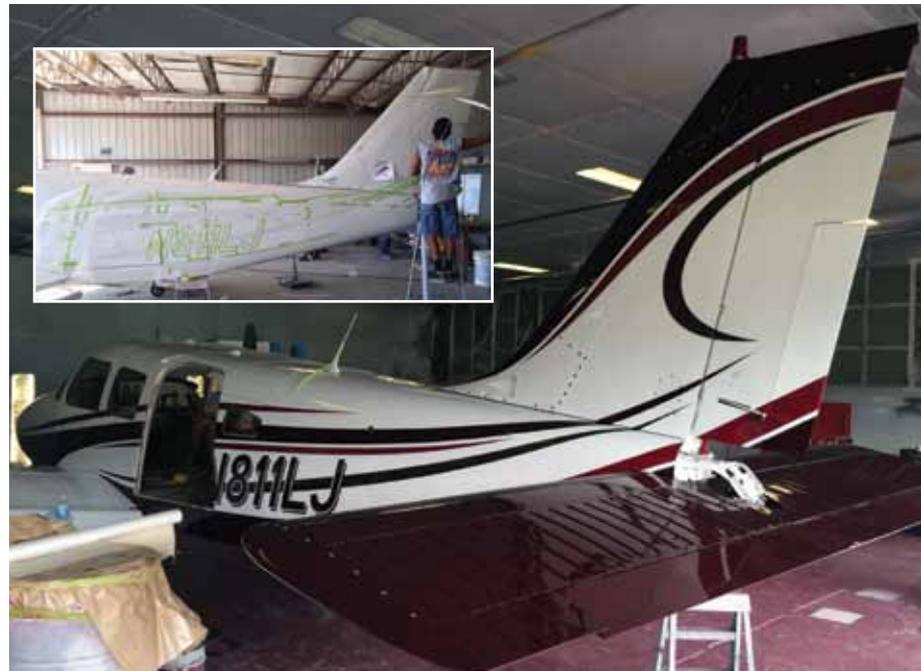
A custom paint scheme was developed and the customer worked with our designers to pick out colors for both the interior and exterior. The Seneca II was stripped; new, thicker, tinted grey windows were installed,

and the door and window seals (two places where noise really enters the cabin) were replaced making for a much quieter aircraft.

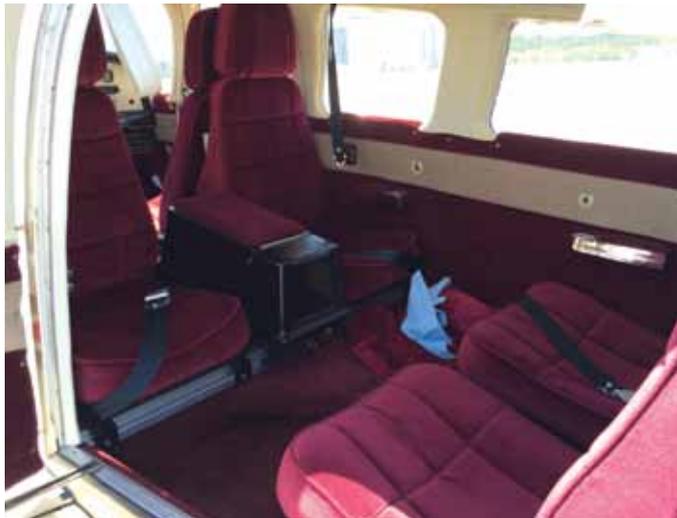
Before

Interior plastic is rather expensive to replace. To save the customer time and money, we wrap existing plastic with fabric. The wrapping not only makes for easier repairs, but also covers up any such repairs for a clean, modern look.

On the inside, the side panels were remade with a much more durable PVC plastic and all of the interior plastic was wrapped with fabric. To finish off the paint and interior re-
